4) 絵図の安定化処理および保存修理

4) Stabilization and Repair of Pictorial Maps

Survey of pictorial maps

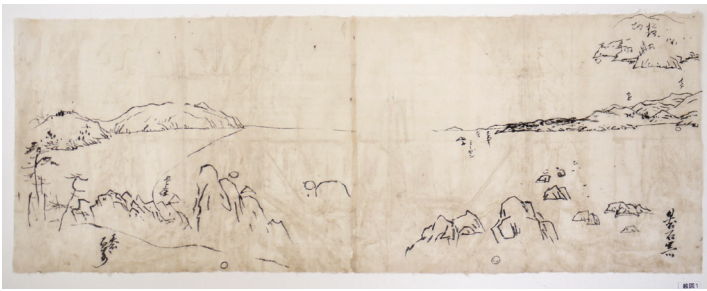
図1 絵図No.1-1(2紙) 紙本墨画 (処置後画像)
Fig. 1 Pictorial map No.1-1 (two sections) / Ink drawing on paper (post-treatment)

法量：No.1-1本紙 縦 830mm×横 313mm
法量：No.1-2本紙 縦 499mm×横 699mm
法量：No.1-3本紙 縦 405mm×横 310mm
法量：No.1-4本紙 縦 367mm×横 287mm
9件の内の1件「NO.1」の本紙は6紙あった。その内、継ぎ合わせが確認できたものを継ぎ合わせた(絵図No.1-1、No.1-2)。残りの2紙については、まとめて保管するようにした。

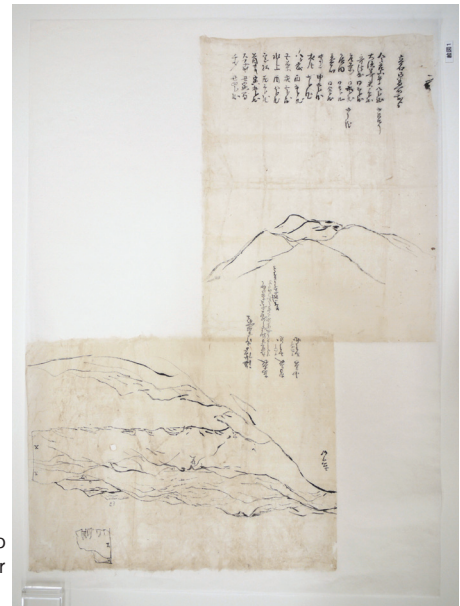
図2 絵図No.1-2(2紙) 紙本墨画 (処置後画像)
Fig. 2 Pictorial map No.1-2 (two sections) / Ink drawing on paper (post-treatment)

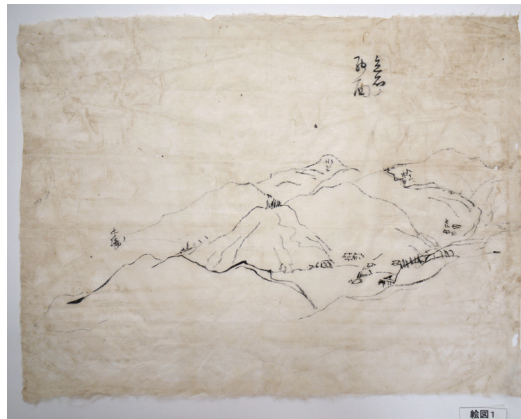
図3 絵図No.1-3(1紙) 紙本墨画 (処置後画像)
Fig. 3 Pictorial map No. 1-3 (one section) / Ink drawing on paper (post-treatment)

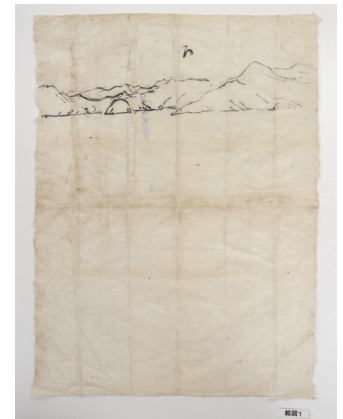
図4 絵図No.1-4(1紙) 紙本墨画 (処置後画像)
Fig. 4 Pictorial map No. 1-4 (one section) / Ink drawing on paper (post-treatment)

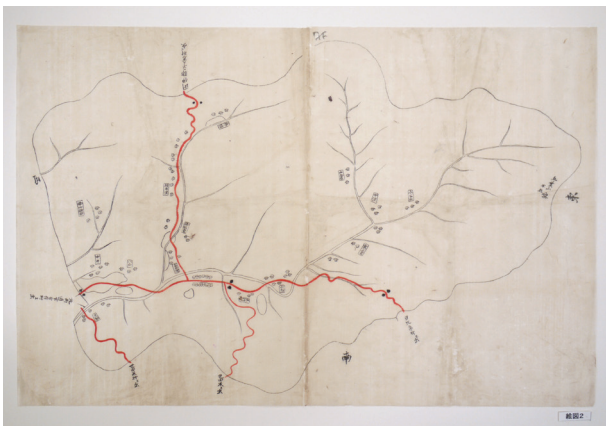
図5 絵図No.2(2紙) 紙本着色 (処置後画像)
法量：No.2本紙 縦 499mm×横 699mm
2紙を継ぎ合わせた。
Fig. 5 Pictorial map No. 2 (two sections) / Color ink drawing on paper (post-treatment)
Size of pictorial map No.2 (height × width): 499mm × 699mm
The sections were joined together.

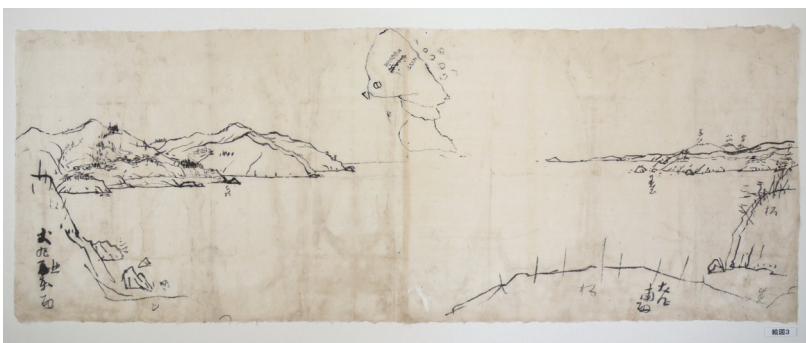
図6 絵図No.3(2紙) 紙本墨画 (処置後画像)
法量：No.3本紙 縦 830mm×横 313mm
2紙を継ぎ合わせた。
Fig. 6 Pictorial map No. 3 (two sections) / Ink drawing on paper (post-treatment)
Size of Pictorial map No.3 (height × width): 830mm × 313mm

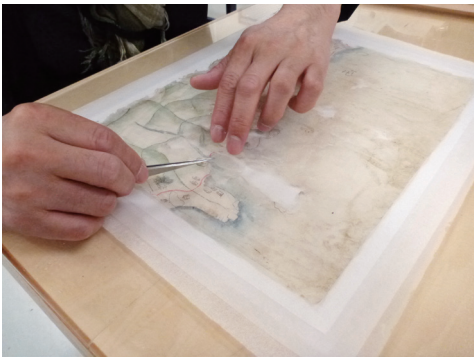
図7 絵図No.7 本紙部分の作業工程写真
本紙左上部分を調整し補修した。
Fig. 7 Pictorial map No. 7, section treatment process
The left upper part of the section was adjusted and repaired.

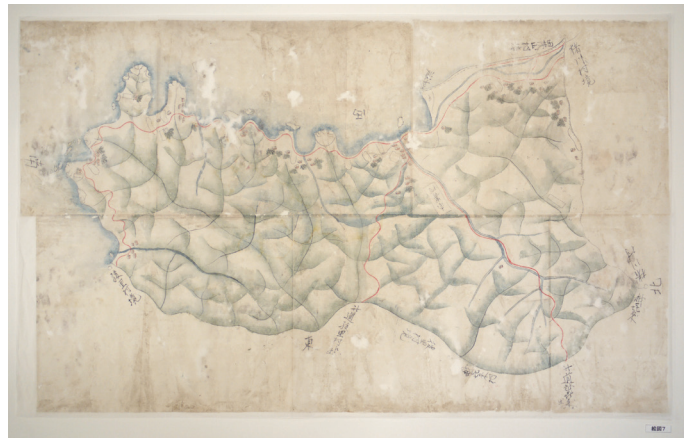
図8 絵図No.7(6紙) 紙本着色(処置後画像)
法量: No.7本紙 縦 885mm×横 542mm
補修し継ぎ合わせて中性紙製紙管に巻いて保存した。
Fig. 8 Pictorial map No. 7 (six sections) / Color ink drawing on paper (post-treatment)
Size of pictorial map No.7 (height × width): 885mm × 542mm
The sections were repaired, joined together, wrapped around a paper tube made of acid-free paper, and stored.

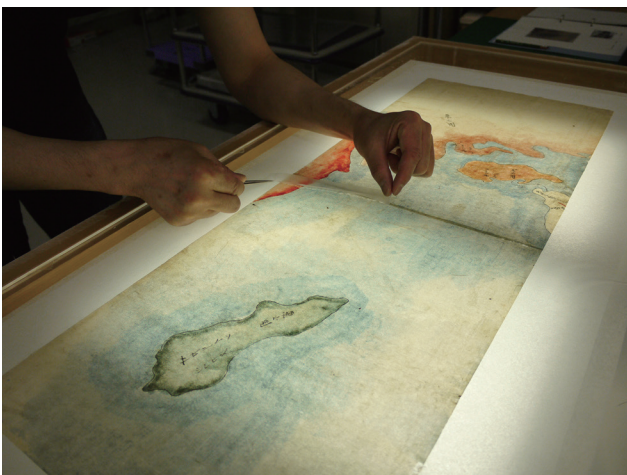
図9 絵図No.9本紙部分の作業工程写真
透過光台にて継ぎ合わせや亀裂箇所を調整し補修を施した。
Fig. 9 Pictorial map No. 9, treatment process on the section
The sections were joined using a light table, and the split parts were adjusted and mended.

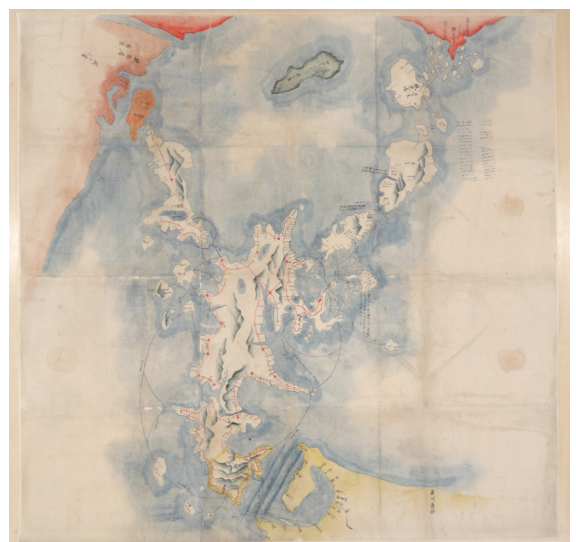
図10 絵図No.9(12紙) 紙本着色(処置後画像)
法量: No.9本紙 縦 1221mm×横 1244mm
補修し継ぎ合わせて中性紙製紙管に巻いて保存した。
Fig. 10 Pictorial map No. 9 (twelve sections) / Color ink drawing on paper (post-treatment)
Size of pictorial map No.9 (height × width): 1,221mm × 1,244mm
The sections were repaired, joined, wrapped around a paper tube made of acid-free paper, and stored.
